Experimental study on the chemico-physical interaction between a two-component cyanoacrylate glue and the material of PICCs

ABSTRACT

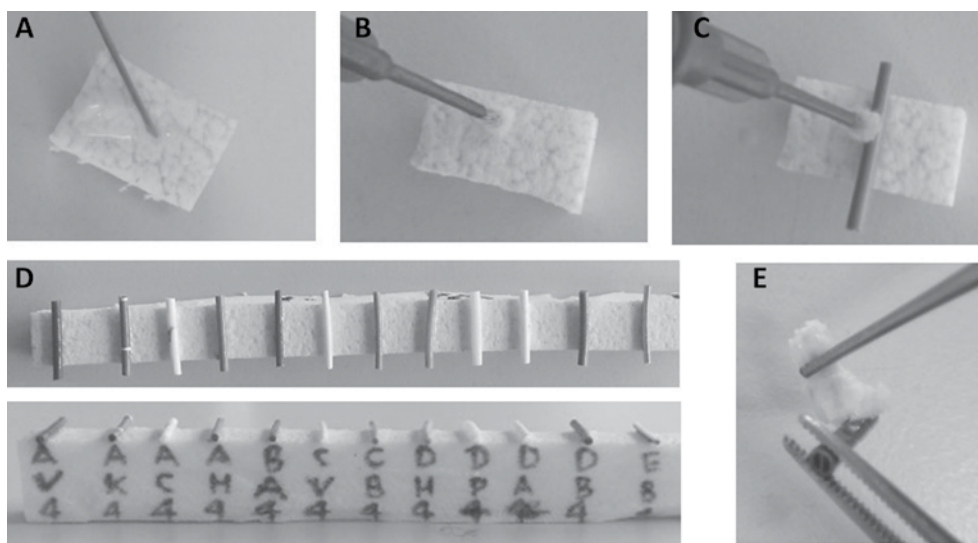
Fig. 1 - Sample preparation procedure: **(A)** a syringe puts a few drops of Earle solution over the artificial skin pad; **(B)** a layer of glue is dropped over the skin; **(C)** the sample is positioned on the skin pad and covered with the glue; **(D)** Pad of samples to be tested at week 4, ready to be put in the incubator; **(E)** Sample removal from the skin pad.

One of the most critical points of the study was to reproduce in vitro the polymerization of the glue, which in vivo is very rapid and strong. The direct apposition of the glue over the PICC line did not produce any polymerization, an effective support was thus necessary. The final and most satisfactory solution was to put the samples on a pad of artificial skin (Wound Closure Pad by *Limbs & Things*), preliminarily wetted with a few drops of Earle saline solution (Biological Industries Israel Beit Haemek LTD) (Fig. 1 A-B-C).

To investigate possible degradation of the PICC secondary to several weeks of contact with the glue, distinct pads were prepared and conserved in an egg incubator at 34°C and relative humidity of 60%. Such values were chosen to simulate in vivo-like conditions (Fig. 1D). Once the desired duration was reached, the due pad was taken out from the incubator and each sample carefully removed from the skin support (Fig. 1E). This step was critical but necessary to observe the PICC surface underneath the glue. In all polyurethane catheters, when detaching the sample from the pad, the glue remained upon the artificial skin, thus exposing the catheter surface to be analyzed (Fig. 1E). On the other side, the silicon catheter (Groshong, Bard) could not be tested: it was weaker than the glue so it broke in the attempt to remove it from the skin pad.

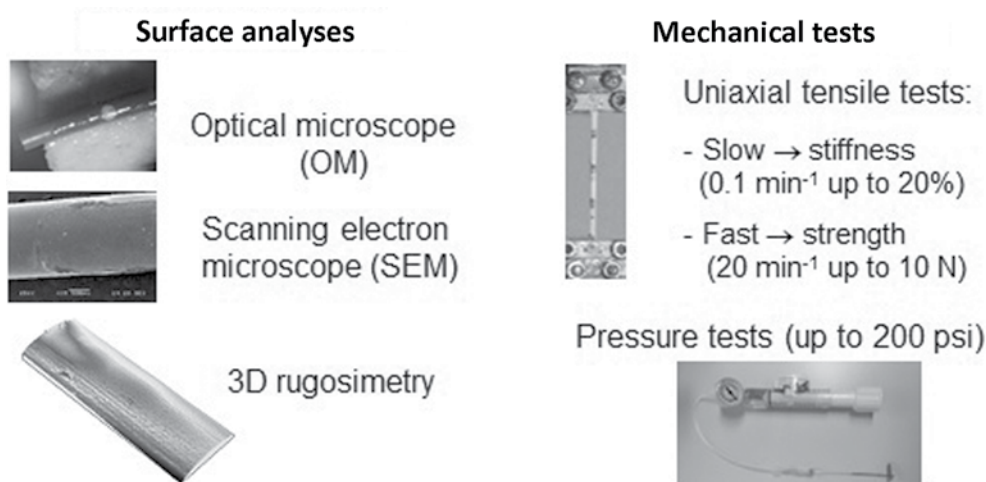
Fig. 2 - Experimental activities: both surface analyses and mechanical tests were performed to detect possible catheter degradation.

The possible degradation of the catheter was investigated by means of surface analyses and mechanical tests, as schematically shown in Figure 2.

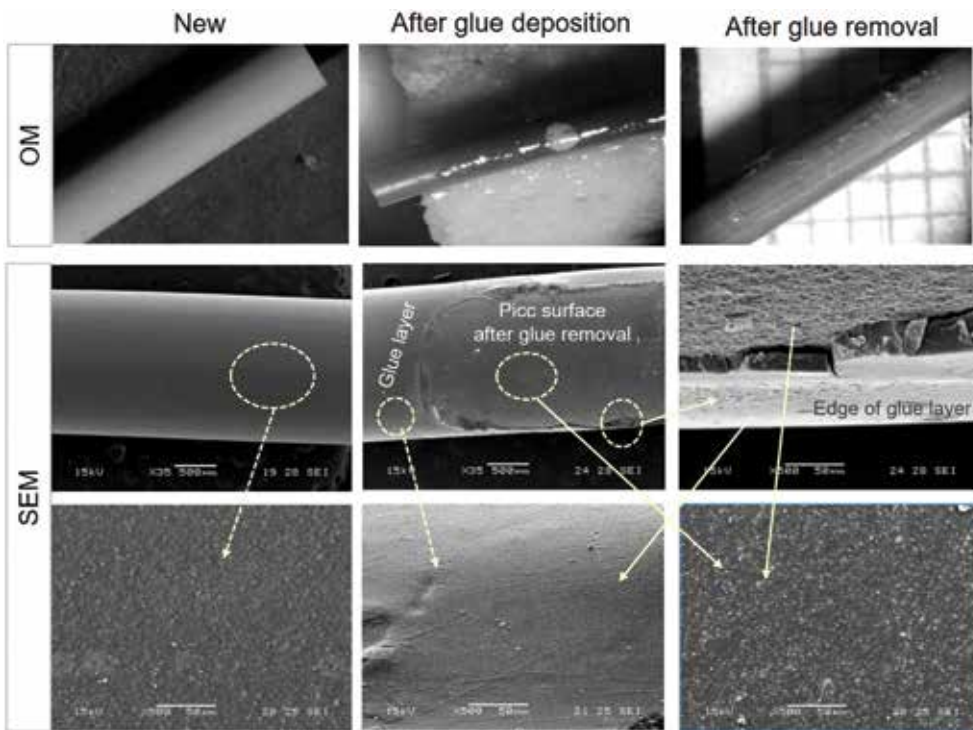
Fig. 3 - Examples of pictures from optical microscope (OM) and scanning electron microscope (SEM) analyses, comparing the initial surface of the PICC to the one covered with glue and to the final one, exposed after glue removal at 8 weeks.

of the glue and for its removal. More detailed information was obtained from SEM analyses, as shown in Figure 3. It can be observed that the pictures of the original PICC surface, compared with those of the surface underneath the glue, exposed after glue removal, show no visible sign of deterioration. The same conclusion was reached for all the samples, i.e., for all tested samples for any duration. The silicon catheter could not be tested after glue removal, as explained above.

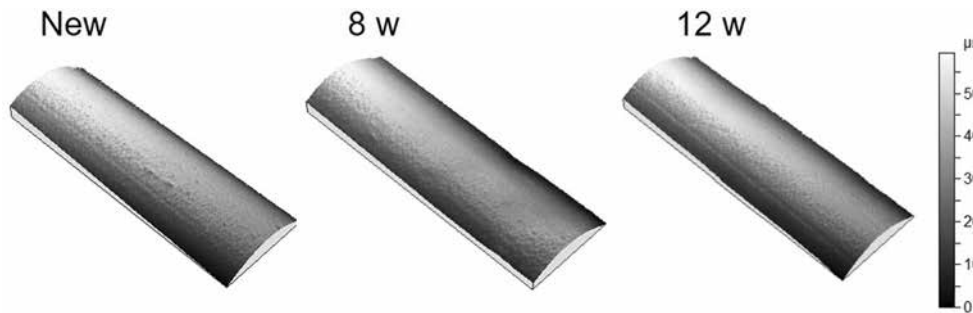
Fig. 4 - Examples of 3D plots of PICC surface, reconstructed by roughness tests: comparison of the initial original (new) PICC surface and the final surfaces at weeks 8 and 12, after glue removal.

In order to get quantitative information on the PICC surface, 3D reconstructions were used. An example of the obtained plots is reported in Figure 4, where the PICC surface is shown in brand new conditions and after glue removal at 4, 8 and 12 weeks from deposition. It can be observed that the manufacturing lines are parallel to the cylinder axis and are still visible also after glue removal, proving that the surface has maintained its micrometric features without detectable signs of damage. As already mentioned, the silicon PICC was not observed as it broke during the preparation phase.

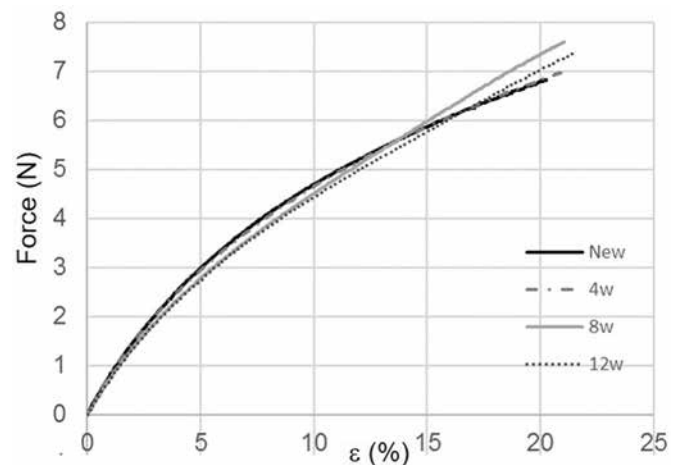
Fig. 5 - Example of load-strain curves obtained from uniaxial tensile tests at slow speed of samples tested after different weeks from glue deposition.

Figure 5 shows an example of the trends of force-strain plots from slow speed tests, obtained for the same model of PICC, but from samples tested after 0, 4, 8, and 12 weeks from glue deposition. In the plots, the nominal strain of the entire PICC is considered. It can be observed that curves are highly overlapped, particularly up to 15%; at higher strains, local effects near the clamps can cause some differences.
